Manhole Inspection Summary

Manhole # S27M__047MH

Insp Date: **5/13/08 11:30 AM**

Location Address: **886 Washington BD**

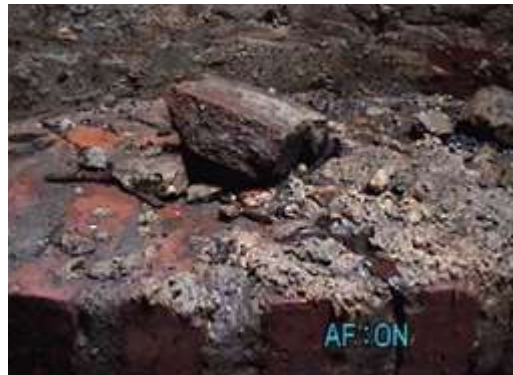
Defect 3

bricks and debris on bench

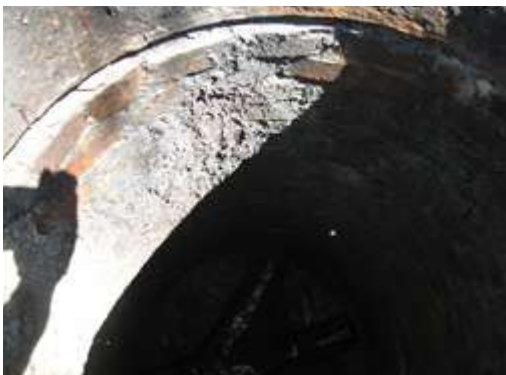
Defect 2

Condition: ☐ Sound ☐ Cracked ☒ **Leaks**

Condition: ☐ Sound ☐ Cracked ☐ Root Intrusion ☐ Loose Brick ☒ **Deteriorated**

Infiltration: ☐ None ☒ **Joint** ☐ Cracks ☒ **Mortar** ☐ Roots ☒ **Wall**

chimney cond deteriorated, joint, mortar, leaks

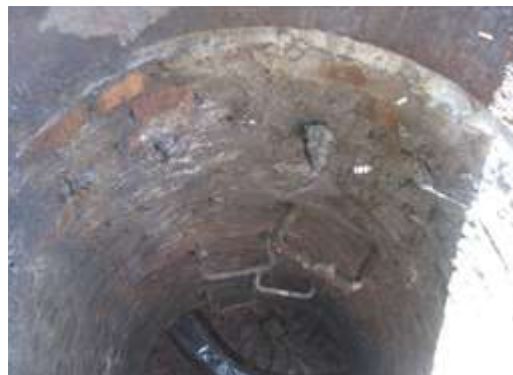
Count: **5** Missing: **1** ☒ **Corroded**

missing steps, steps corroded, chimey flow wall

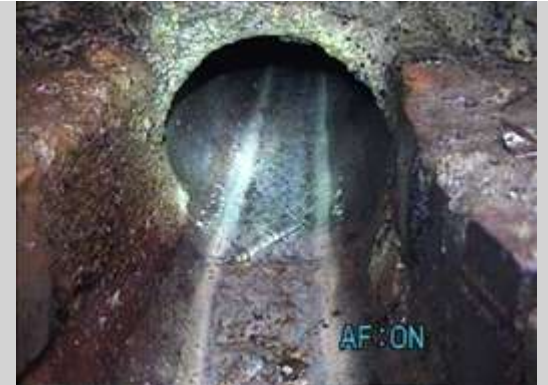
12 O'Clock Outflow

8 in. Circular Gravity Sewer
Pipe Out @ 12 O'Clock

Pipe Height: **8.4** (in.) Rod and Bar (Angled)
Pipe Material: **Clay** ☐ Pipe Lined
Invert Depth: **9.62** (ft.) Flow Characteristics: **Slow**
Deposits: ☒ None ☐ Mud ☐ Sludge ☐ Debris ☐ Grease
Silt Depth: **0** (in.) Deposits Extent:
Infiltration: **None** Pipe Seal Cond: **Sound**

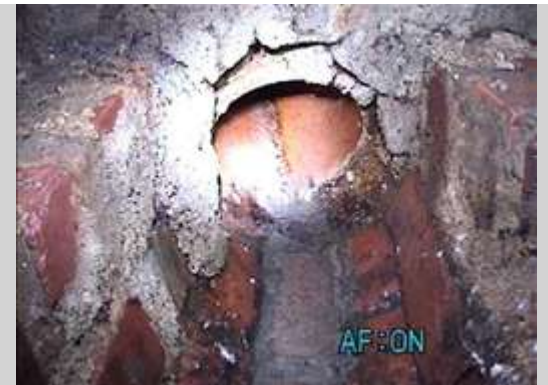
4 O'Clock Inflow

6 in. Circular Gravity Sewer
Pipe In @ 4 O'Clock

Pipe Height: **6** (in.) Rod and Bar (Angled)
Pipe Material: **Clay** ☐ Pipe Lined
Invert Depth: **9.28** (ft.) Flow Characteristics: **Slow**
Deposits: ☒ None ☐ Mud ☐ Sludge ☐ Debris ☐ Grease
Silt Depth: **0** (in.) Deposits Extent:
Infiltration: **None** Pipe Seal Cond: **Unknown**

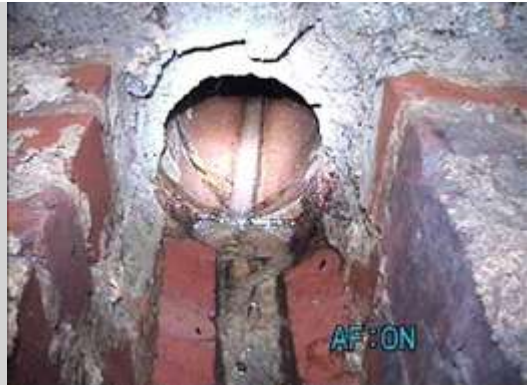
6 O'Clock Inflow

6 in. Circular Gravity Sewer

Pipe In @ 6 O'Clock

Infiltration: **None** Pipe Seal Cond: **Unknown**

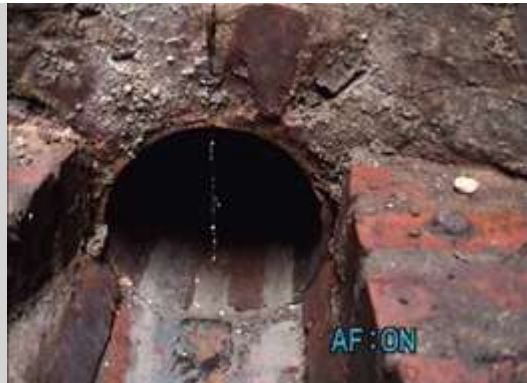
8 O'Clock Inflow

8 in. Circular Gravity Sewer

Pipe In @ 8 O'Clock

Infiltration: **None** Pipe Seal Cond: **Sound**
